UNDERWATER BRIDGE INSPECTION REPORT

STRUCTURE NO. 24514

MSAS NO. 109

SHELL ROCK CHANNEL

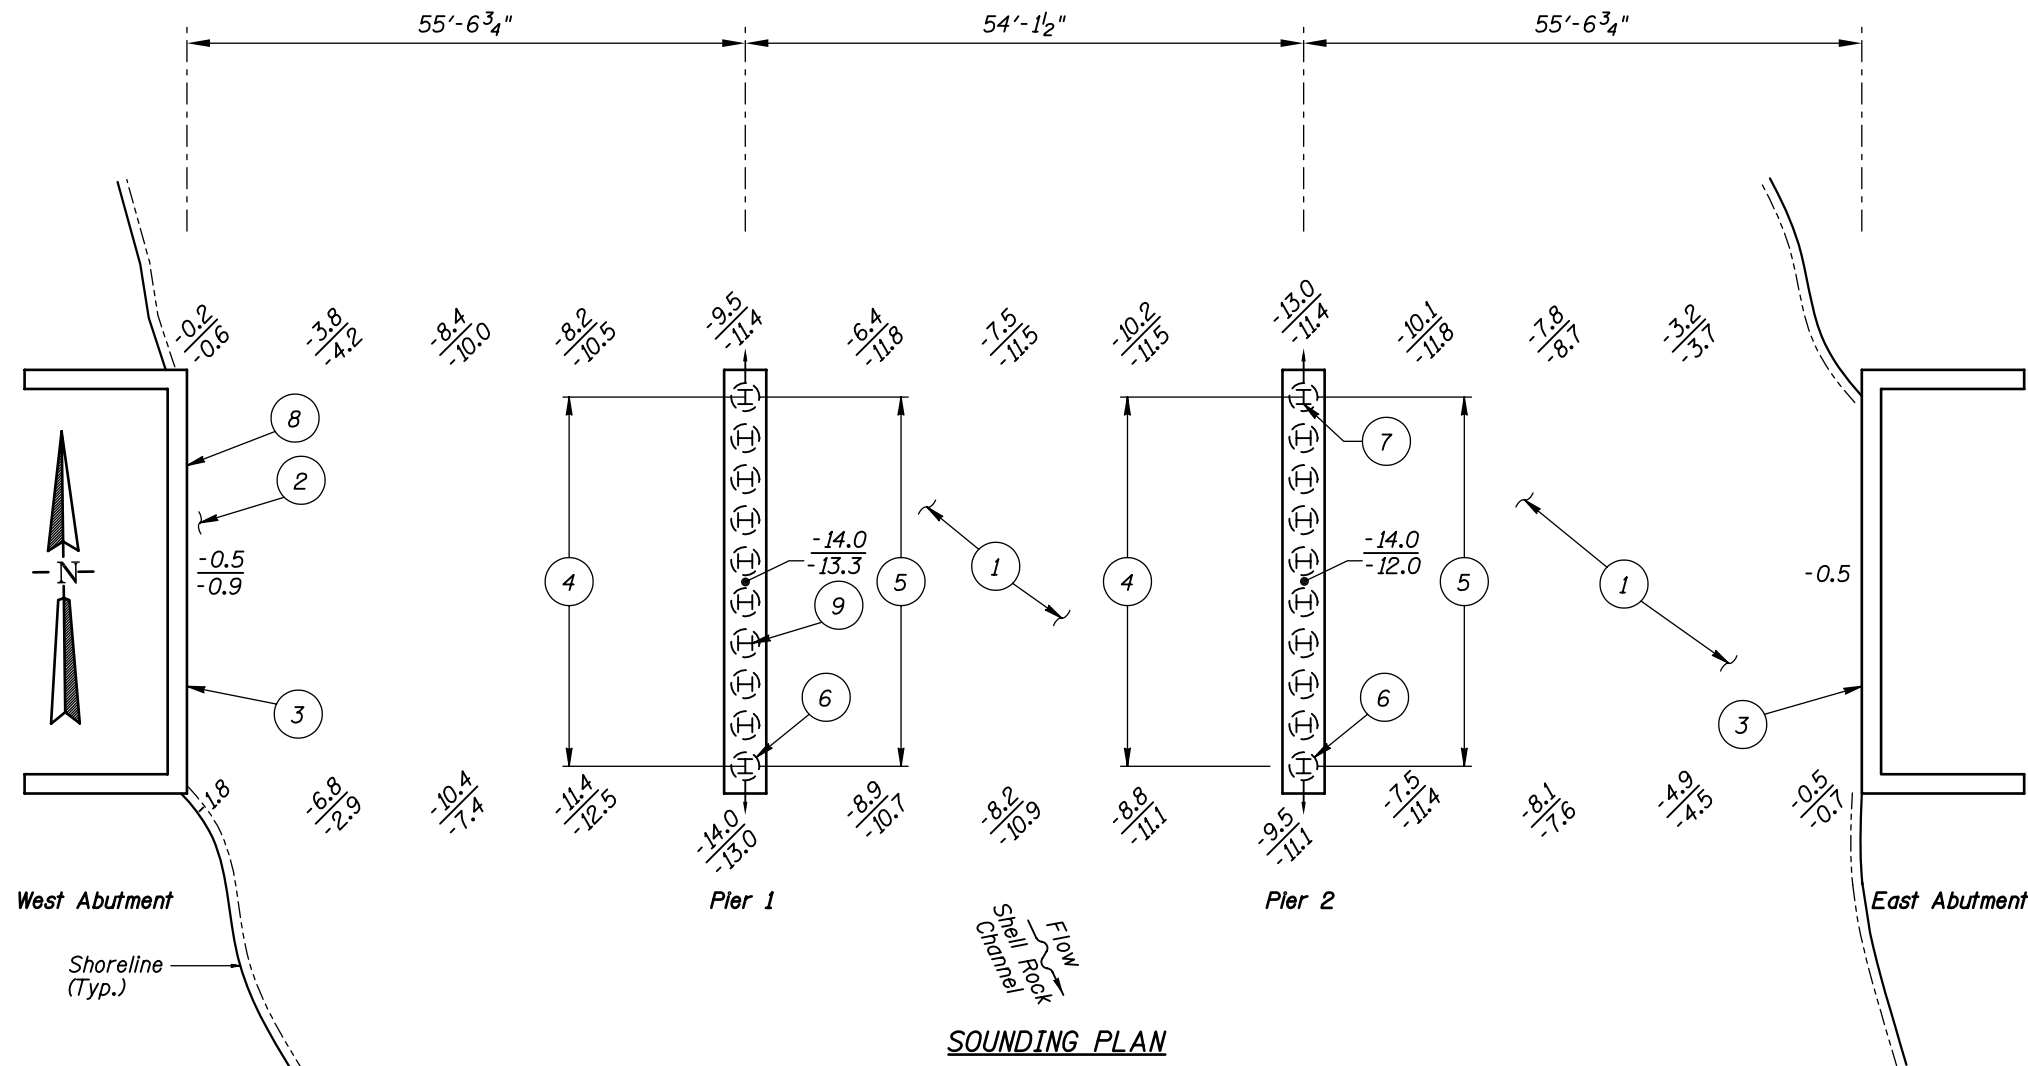
INSPECTION AND SOUNDING PLAN

- The channel bottom consisted of silty sand with up to 1 foot of probe rod penetration.
- The channel bottom consisted of cobbles and rocks up to 2 feet in diameter.

- Overall, the concrete abutments were in good and sound condition with no structurally significant defects observed.
- The steel H-piles exhibited 100 percent coating failure with moderate surface corrosion with up to 1/4-inch-diameter rust nodules.

- The concrete encasements exhibited areas of section loss with up to 6 inches of penetration and exposed reinforcing from 10 inches above to 3 feet below the waterline.

- Timber and steel formwork was still in place.
- A weld-splice of steel H-pile was observed 7.5 feet below the waterline and was in good condition.
- An area of section loss, 2 feet high by 2 feet wide, was observed above the waterline with up to 1 inch of penetration.

- Reinforcing steel was wrapped around the upper portion of the pile.

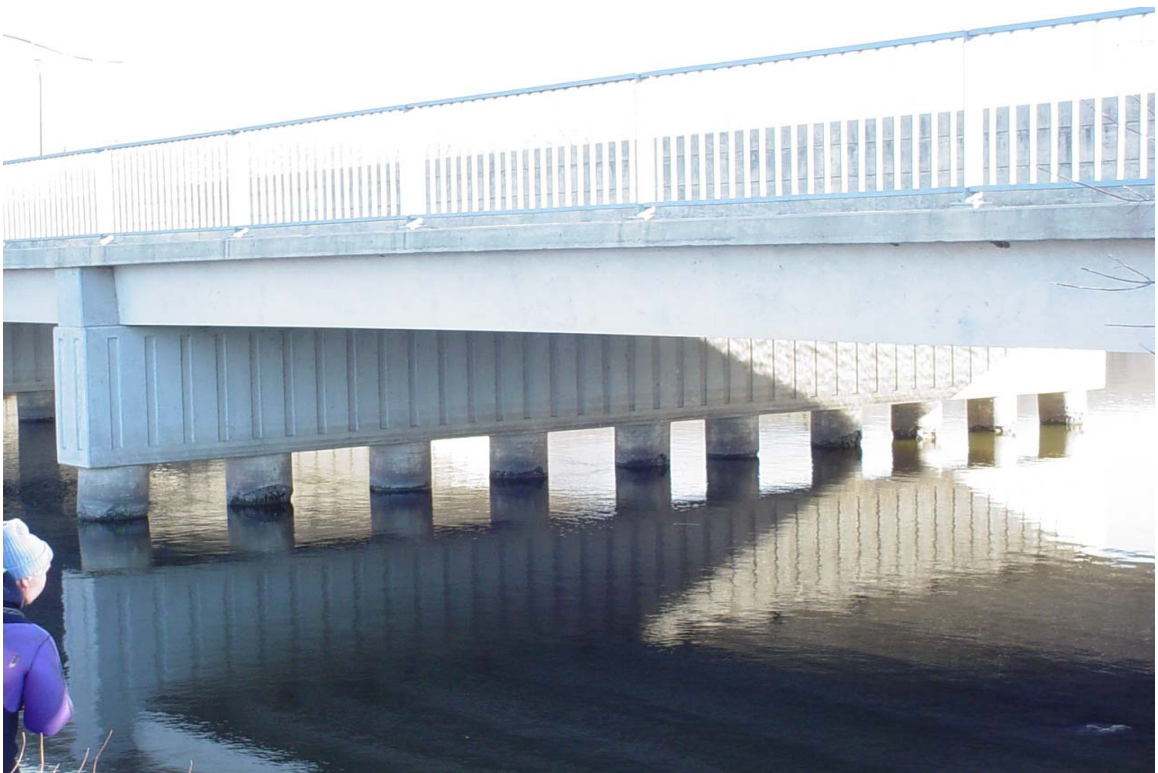
Photograph 2. View of Pier 1, Looking Southeast.

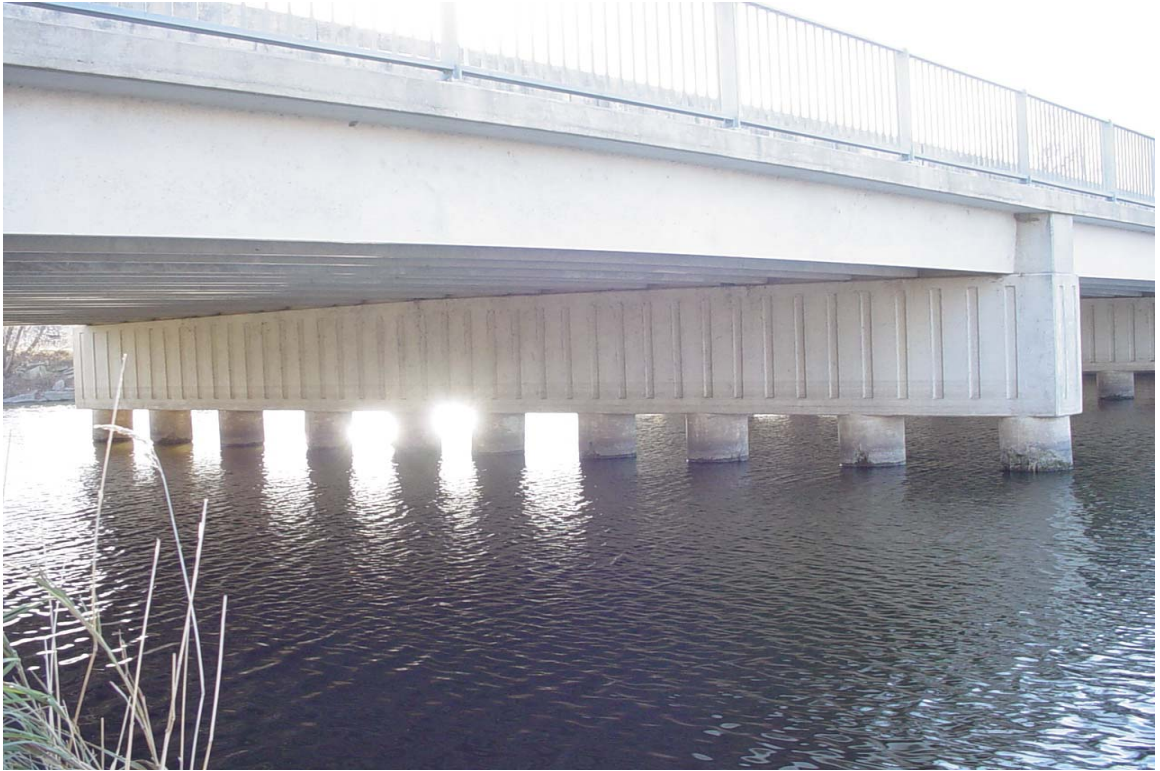
Photograph 3. View of Pier 2, Looking Southwest.

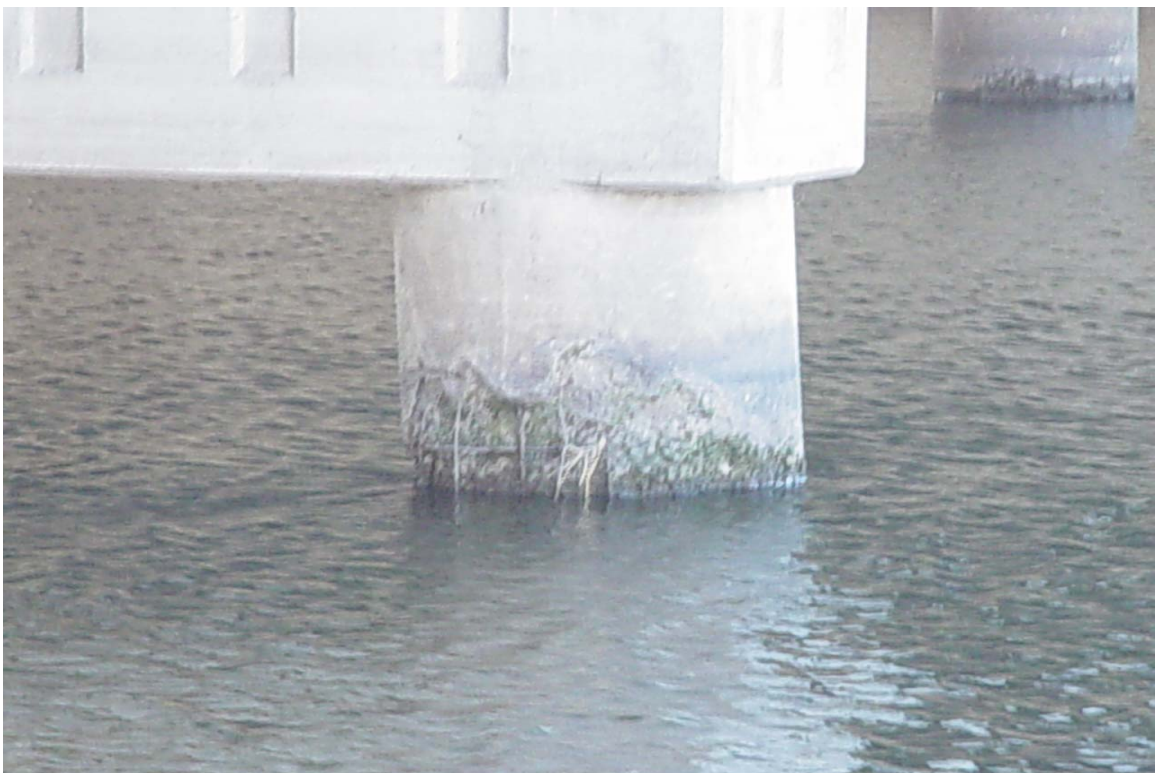
- (A) The concrete encasements on the steel piles at the piers exhibited areas of section loss with up to 6 inches of penetration and exposed reinforcing from 10 inches above to 3 feet below the waterline.
- (B) The steel H-piles exhibited 100 percent coating failure with moderate surface corrosion and up to 1/4-inch-diameter rust nodules, but with no appreciable loss of section.
- (C) A welded splice on the upstream steel H-pile of Pier 2 was observed 7.5 feet below the waterline and was in good condition.
- (D) An area of section loss, 2 feet high by 2 feet wide, was observed above the waterline on the West Abutment with up to 1 inch of penetration.

Photograph 4. View of the Typical Concrete Pile Encasement Condition.

- (A) To prevent further deterioration of the concrete encasements of the steel H-piles, it is recommended that the reinforcing steel be cleaned and the areas of section loss be patched with a grout mix with high durability and low permeability. It should be noted that the repair of the encasements would be for cosmetic and pile protection reasons, and that overall pier integrity has yet to be adversely affected by the encasement problems.
- (B) Reinspect the submerged substructure units at the normal maximum recommended (NBIS) interval of five (5) years.

To prevent further deterioration of the concrete encasements of the steel H-piles, it is recommended that the reinforcing steel be cleaned and the areas of section loss be patched with a grout mix with high durability and low permeability.
